Condition Report

Assignment Number 484-405-0006

Insured: Clay County Vehicle: 2023 Ford Explorer VIN #: 1FM5K8AC0PGA32340

2023 Ford Police Interceptor Utility Fleet 4 Door Utility 3.0L 6 Cyl Gas Injected Turbocharged AWD

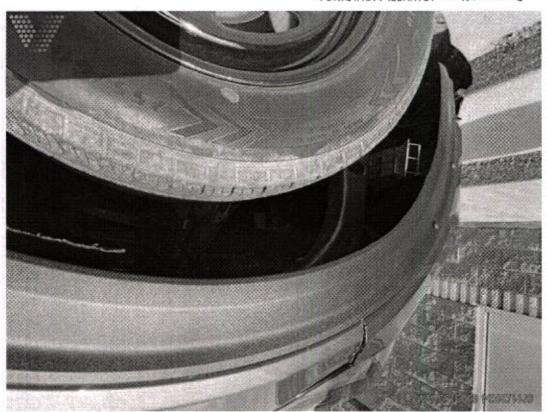
Document Name: LF CORNER.jpg Remarks:

Primary Damage: Left Front Corner
